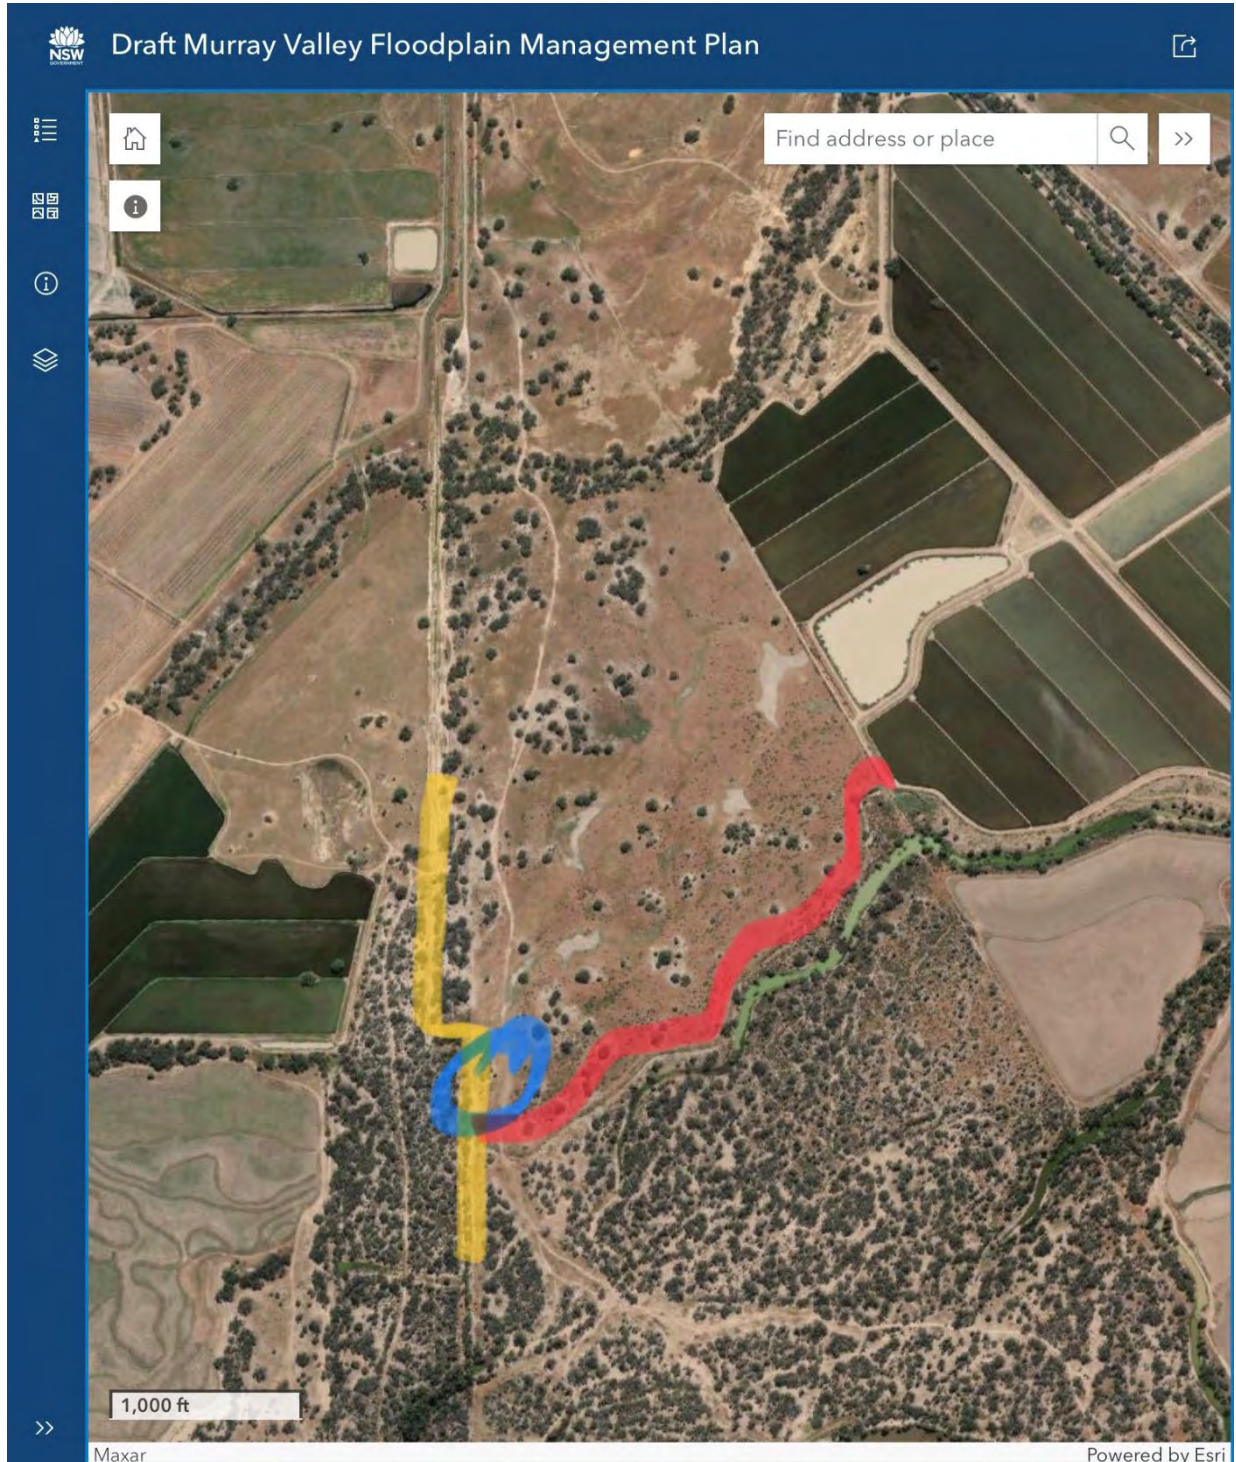
Image 8; Property showing continuation of the [redacted] shown in red- noting that it continues along through the neighbouring property to the right as the Southern edge of the irrigated section. It eventually meets up with the [redacted] Embankment. The [redacted] bank defect area is shown in yellow, and the major defect-intensive sandbagging and breach point is circled in blue.

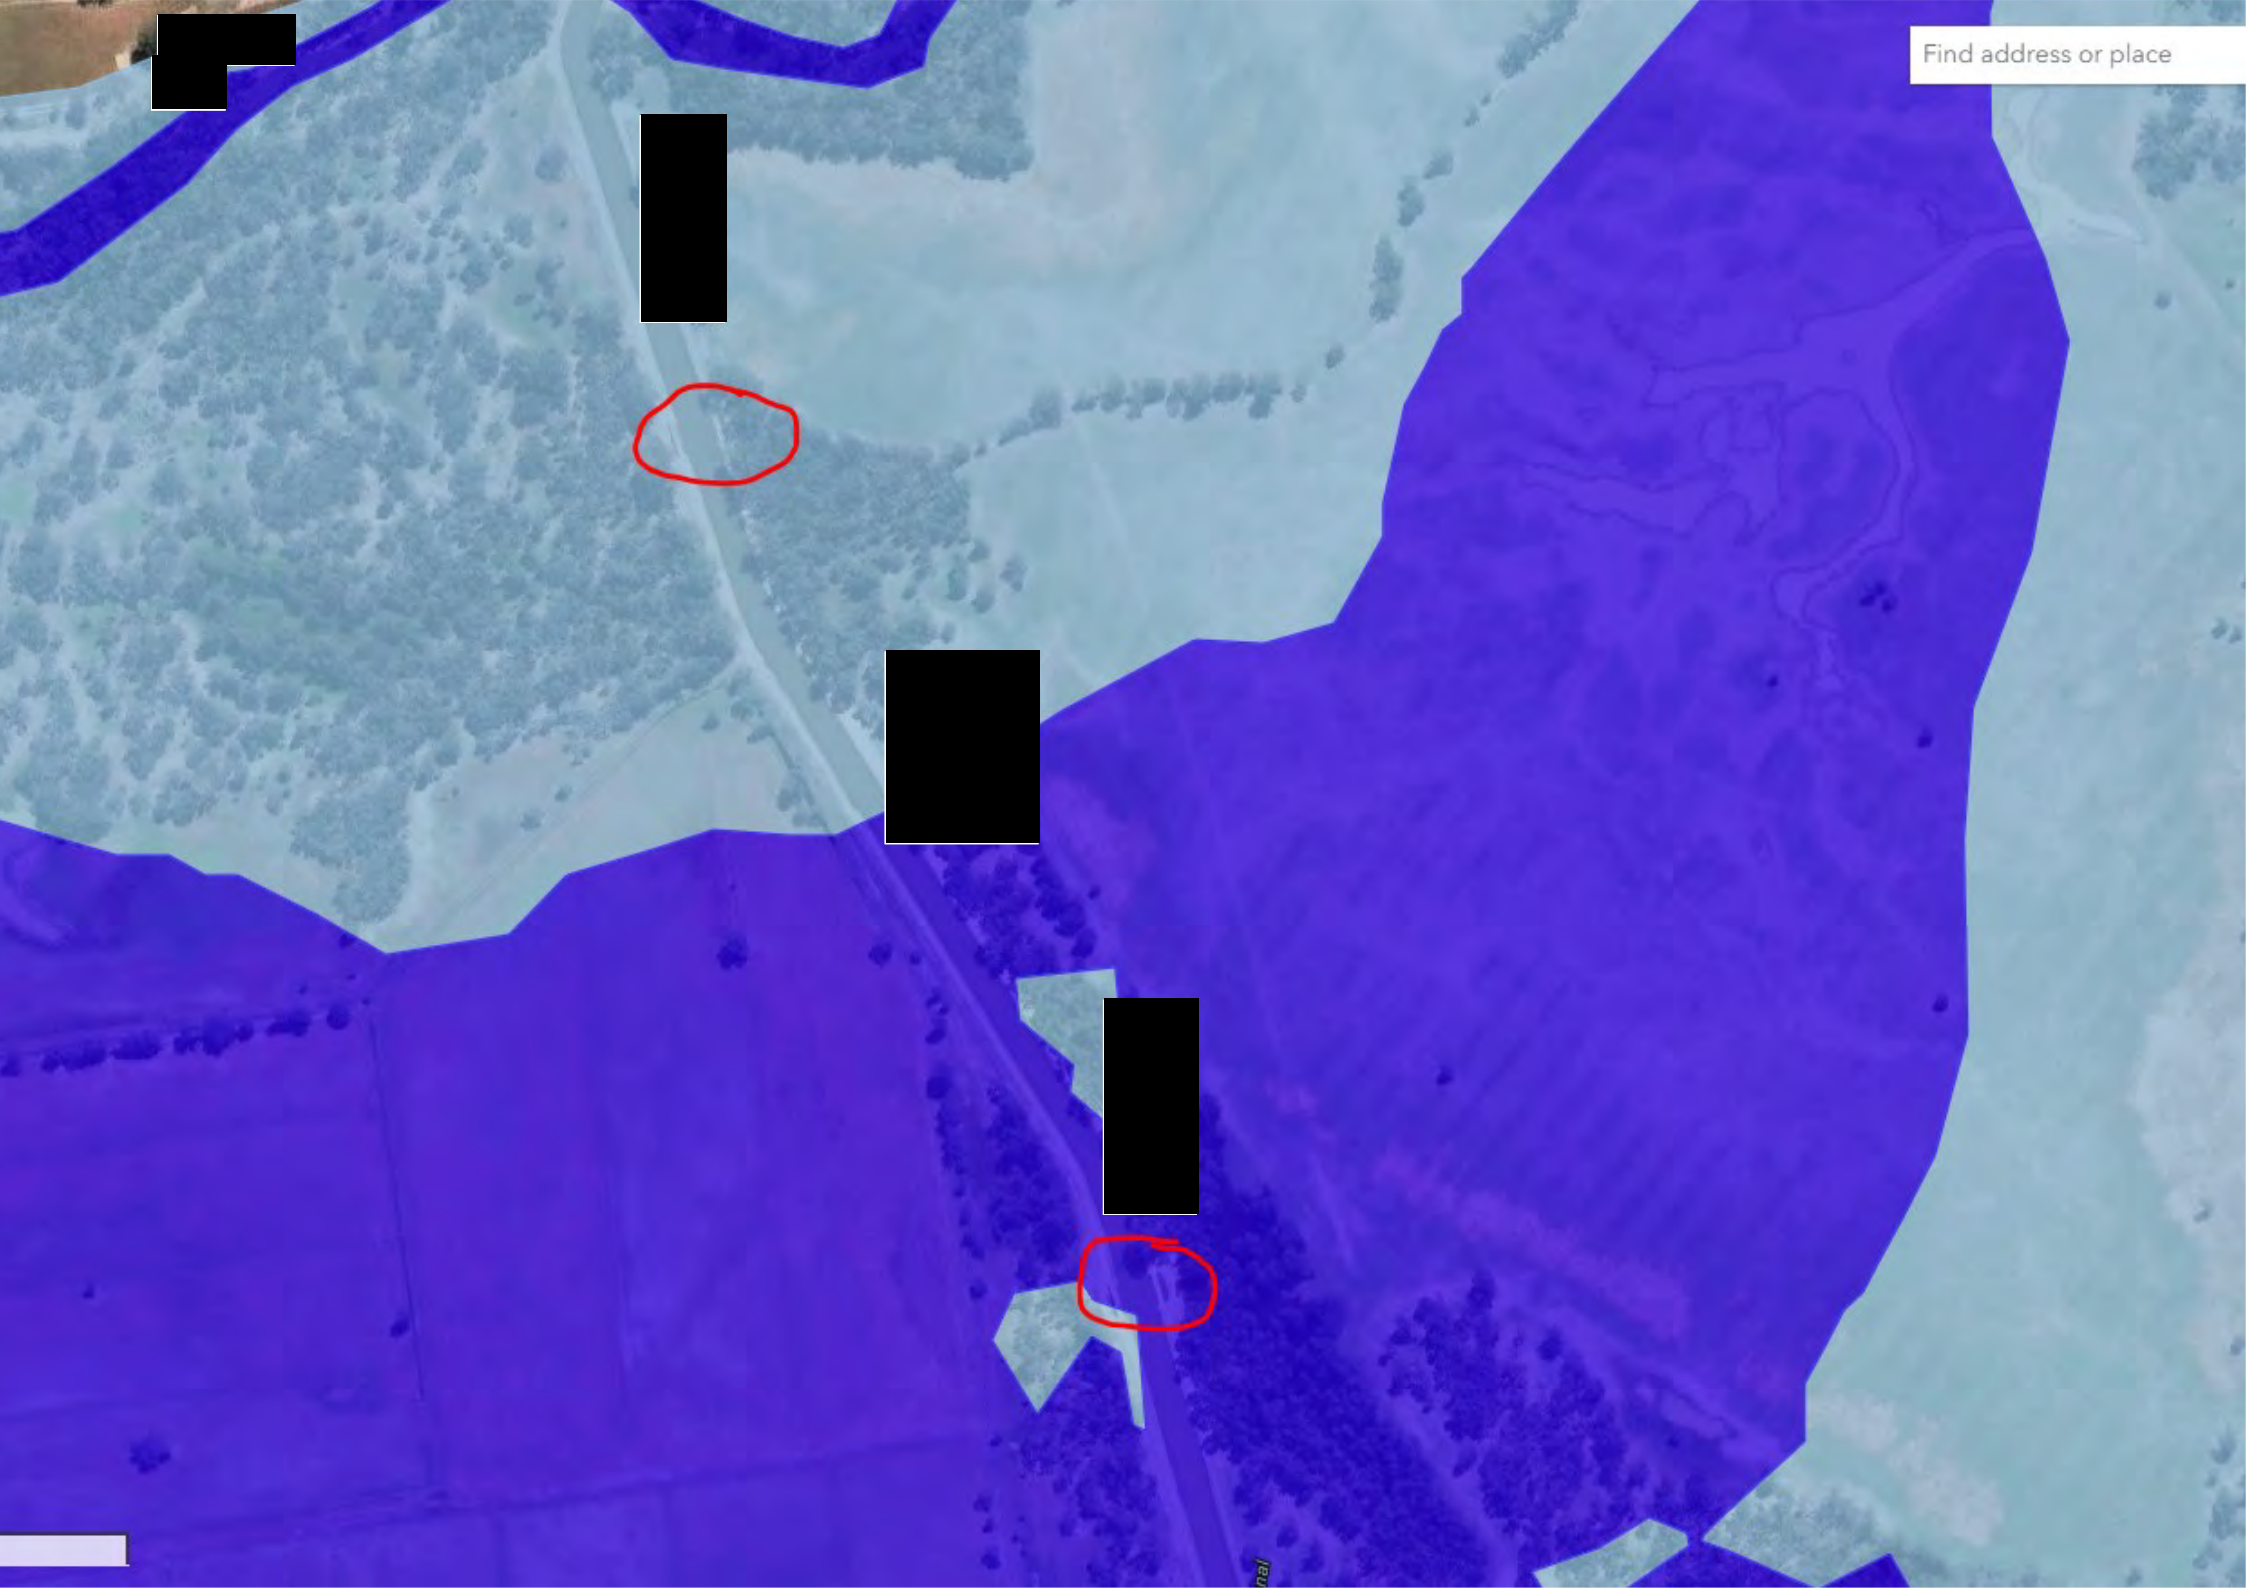
Image 7c: Flood extent as at 01.12.2022. Note the inundation areas due to the Escape Channel bank deficiencies.

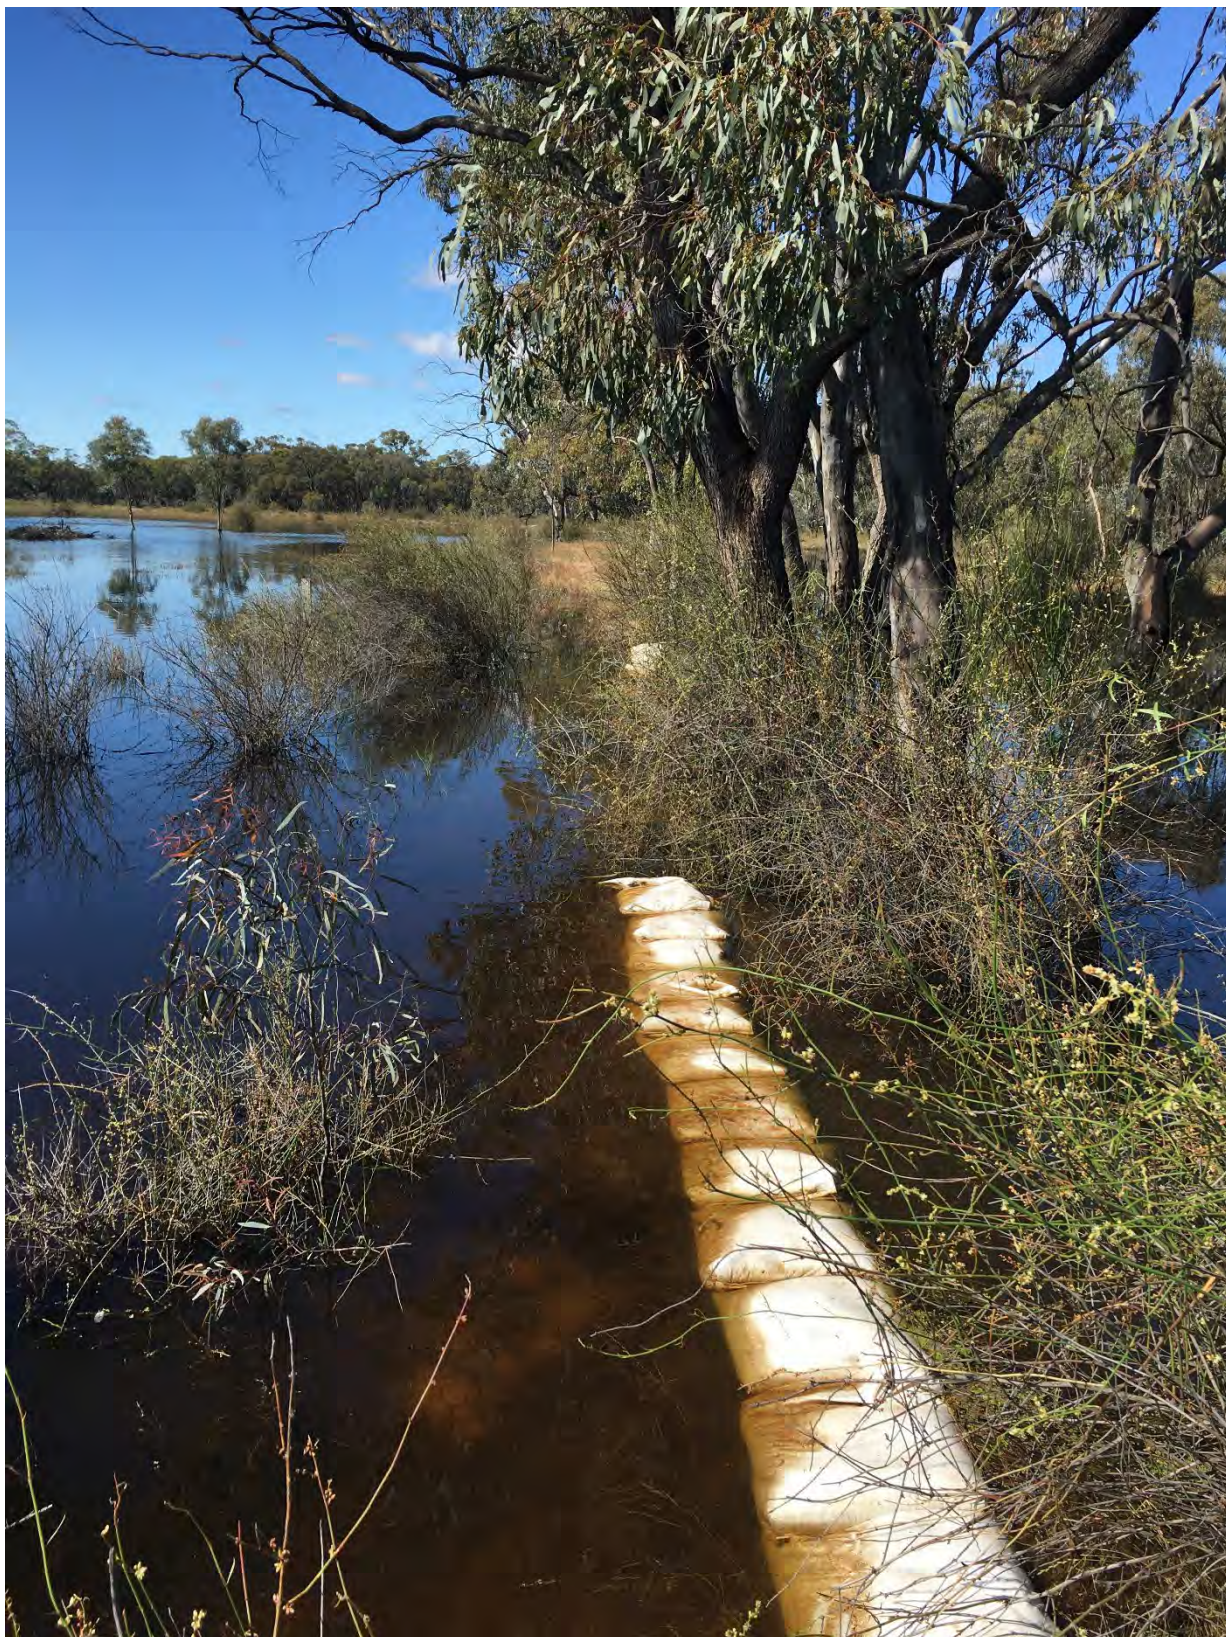
Image 9b: Same spot after sandbagging attempts. Note the property flood level. You can see that the [REDACTED] is still clear in the background (at the foot of the treeline).

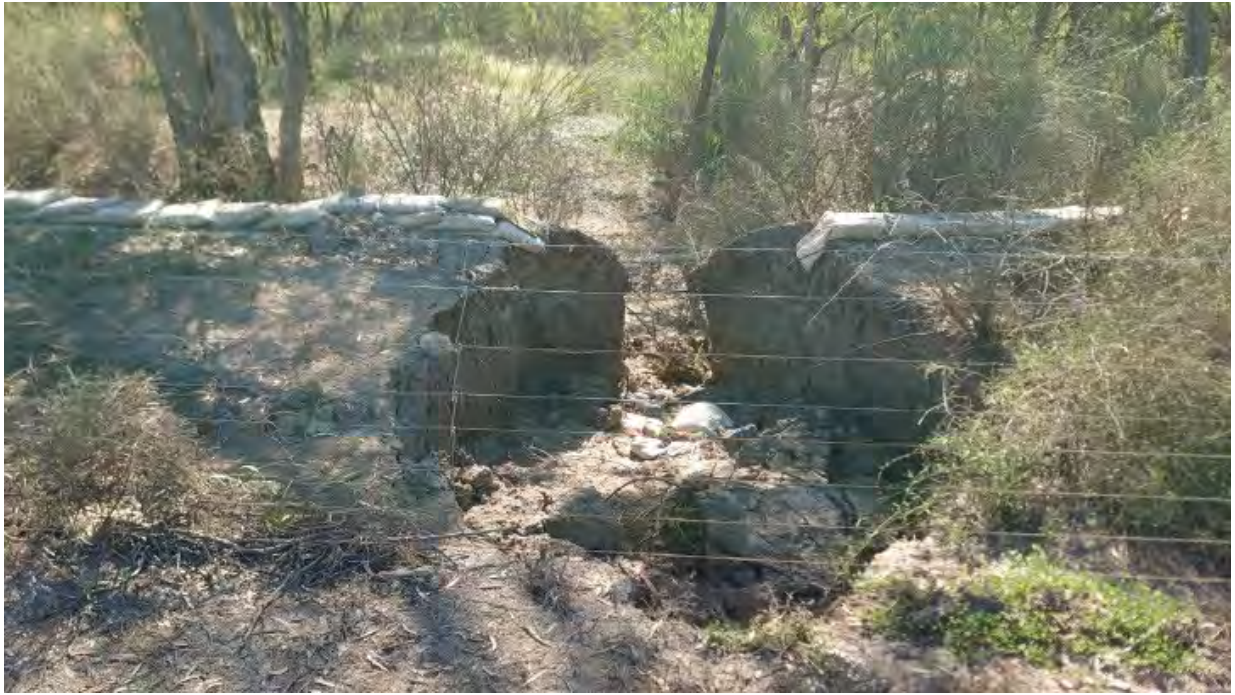
Image 9c :Breach in the [REDACTED] post flooding 2022/2023.
