Fairfield's high risk dams

Flood Detention Basins

Three tributaries FRMS&P

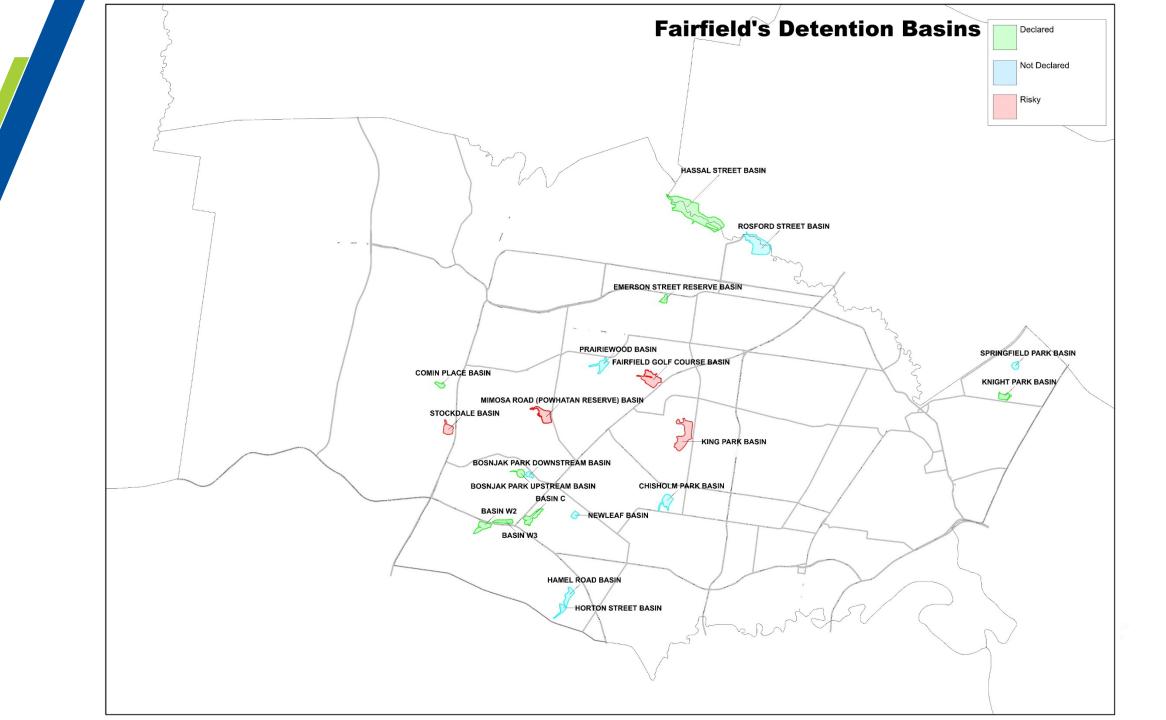
- High A Consequence Category
- Capacity 208ML
- Spills over embankment in 1% AEP event

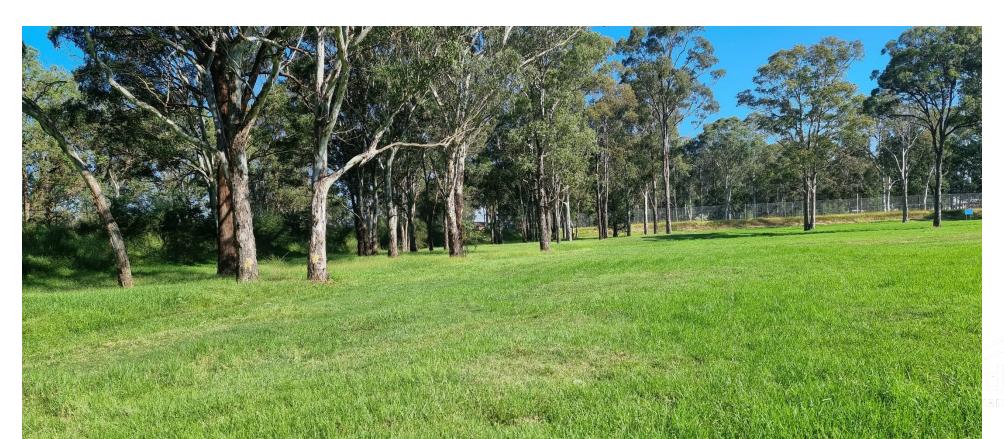
- Remove 100 trees from embankment
- Raise embankment to contain 1% AEP

- High A need to pass PMF
- BSC Pass 1 in 1000 year
- 290m reinforced turf spillway
- Debris control structure

- Removal of trees Biodiversity Conservation Act
- Aboriginal Heritage
- Contamination
- Lime stabilisation
- Chain for debris control structure
- Stakeholders

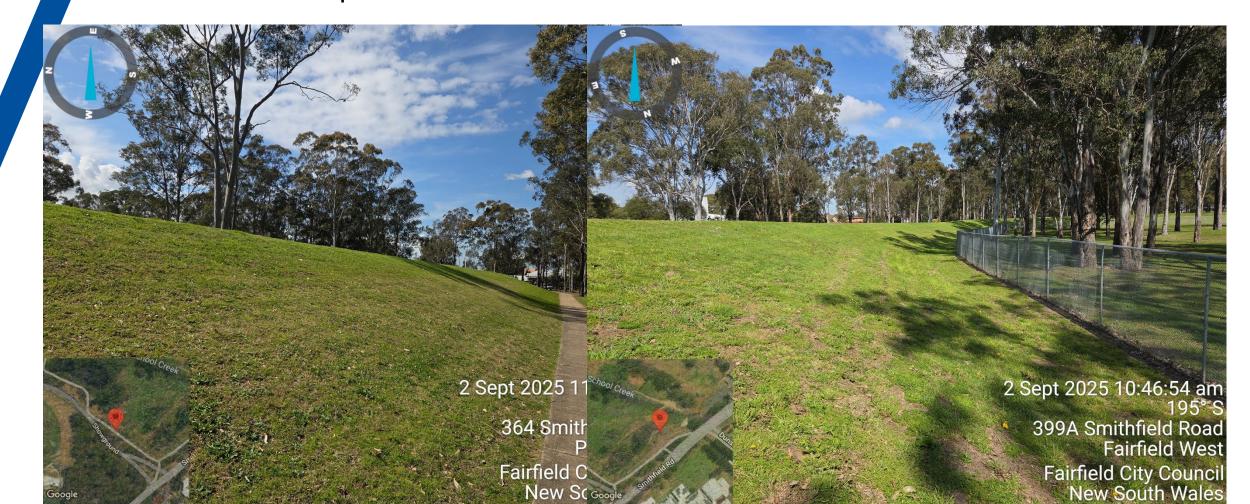
2. Mimosa Road Detention Basin

- High C consequence category
- Capacity 45ML
- Spills over embankment in 5% AEP event

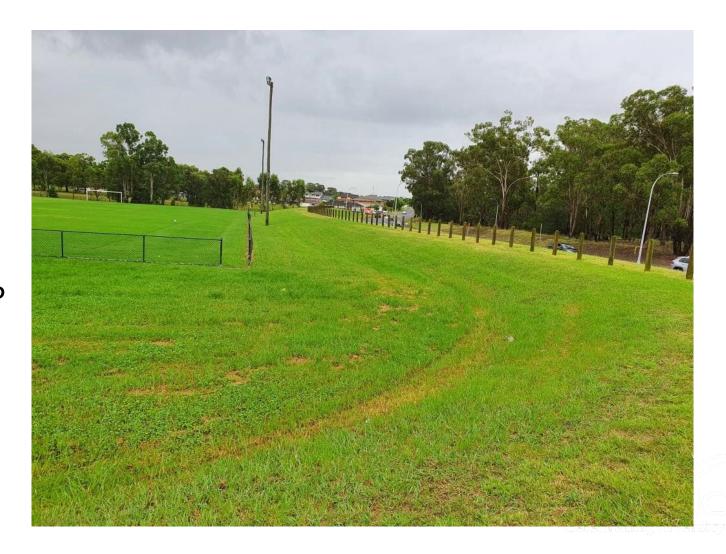
2. Mimosa Road Detention Basin

- Raise embankment to contain 1% AEP
- High C need to pass 1 in 100,000
- BSC pass 1 in 500 year
- 196m reinforced turf spillway
- Replace existing Ø2450mm pipe under road with a 2400(H) x 3000(W) box culvert
- Energy dissipation downstream baffle blocks
- Sydney Water Ø1350mm main bridging slab

- Contamination
- Sydney Water Ø1350mm main
- Endeavor Energy
- Rainfall events delays and rework
- Variations cost and time
- Managing expectations traffic, sporting clubs, pedestrians

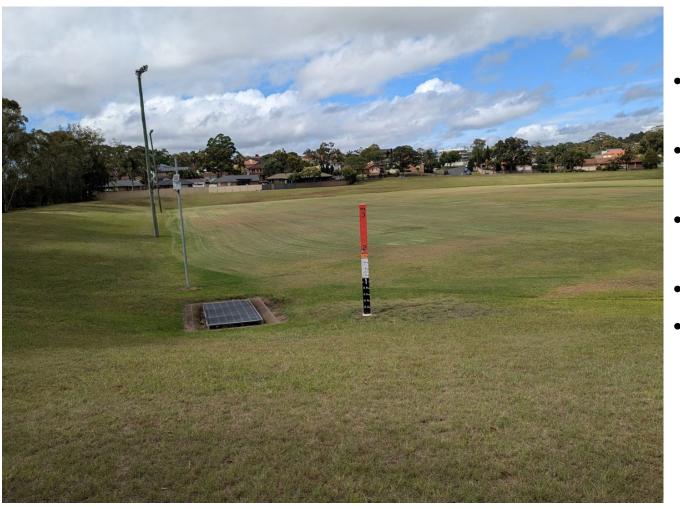
3. Stockdale Reserve Detention Basin

- Raise embankment to contain
 1% AEP
- High C need to pass 1 in 100,000
- 50m concrete and reinforced turf spillway
- Cut off wall to stop pond seepage
- Privacy screening
