Case study - MidCoast Council

Managing a chemical overdose incident

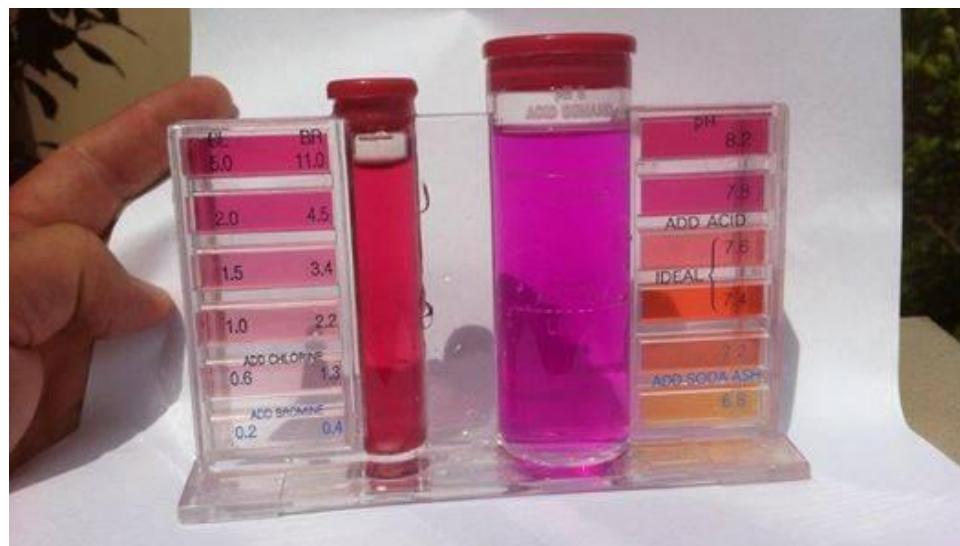
Figure 2. Commercial customer self-testing of the drinking water shows very high levels of chlorine. Gloucester Advocate, 25 March 2015.

- an online residual chlorine analyser with alarms was installed to automatically notify operators of incorrect chlorine dose
- additional daily visual operational checks were implemented, noting chemical storage volumes.
