# Community update for Barwon-Darling, Menindee Lakes and Lower Darling-Baaka river

## New water monitoring pontoons

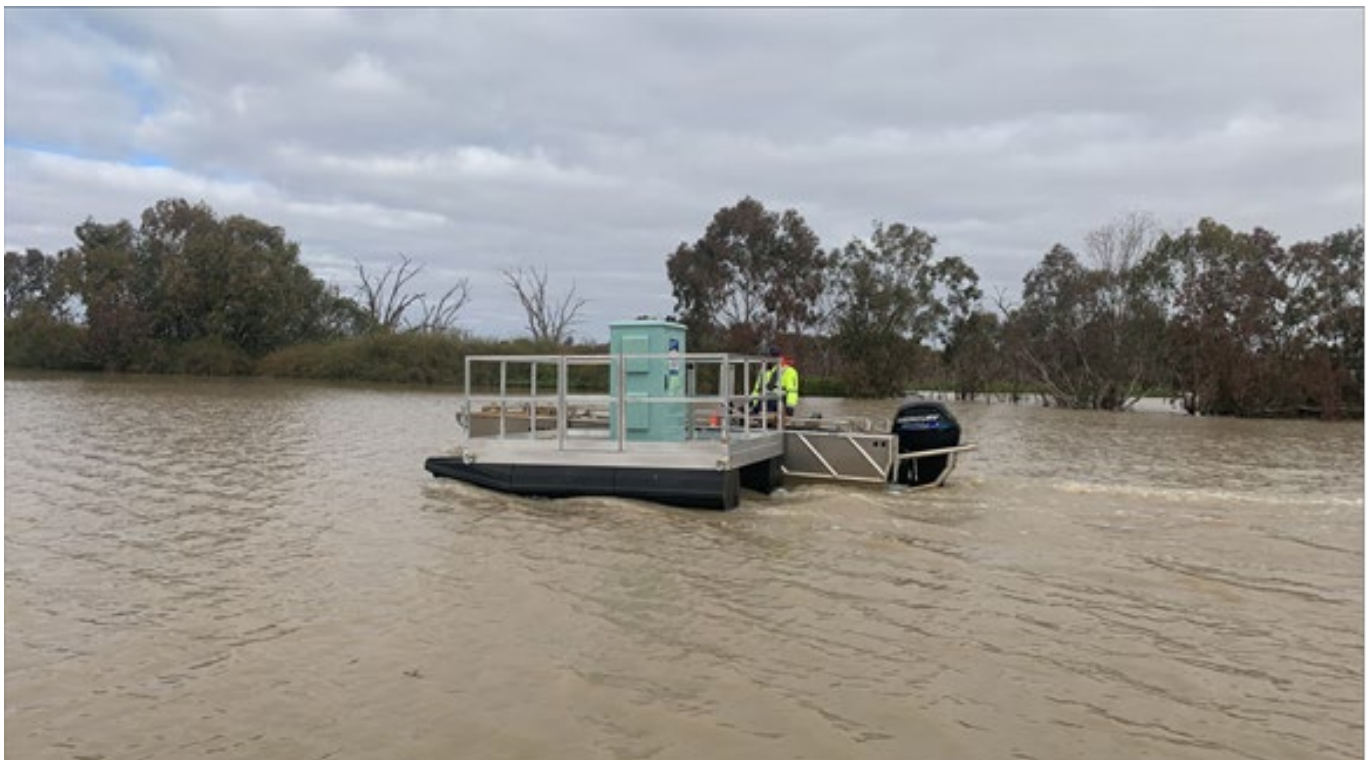
*One of the monitoring pontoons moving into position on Lake Wetherell.*

Each pontoon has 3 fixed-depth profile, multi-parameter and self-cleaning water quality sensors that measure water quality at three levels throughout the water column. The recorded parameters are electroconductivity, temperature, dissolved oxygen, turbidity, pH and total algae. This will give a clearer picture of what's happening below the surface. The real-time data will be available online in the coming weeks. Two of the pontoons replace WaterNSW buoys that were in the weir pool (but

in different locations) and the extra pontoon in Lake Wetherell will help us better understand the quality of the water flowing towards Main Weir and Lake Pamamaroo.
